## FT5 - Greystanes Creek, Toongabbie

### Site Information

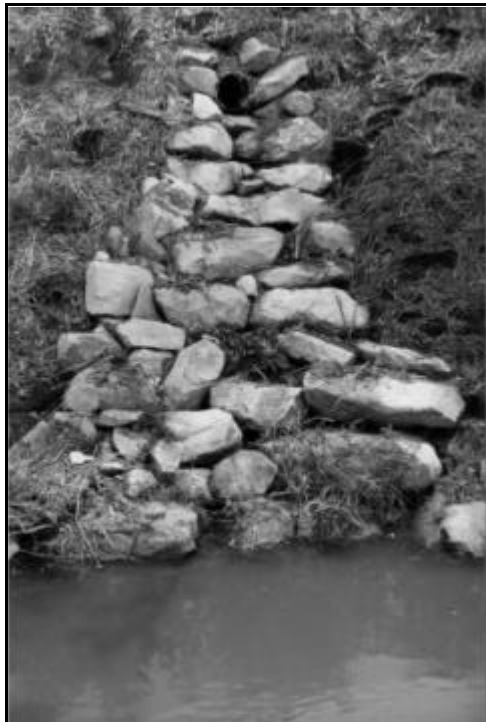
*Stormwater drain and bank stabilised with rocks for energy reduction during storm events. Plastic structures next to rock extend 2 metres back into creek bank. (left)*

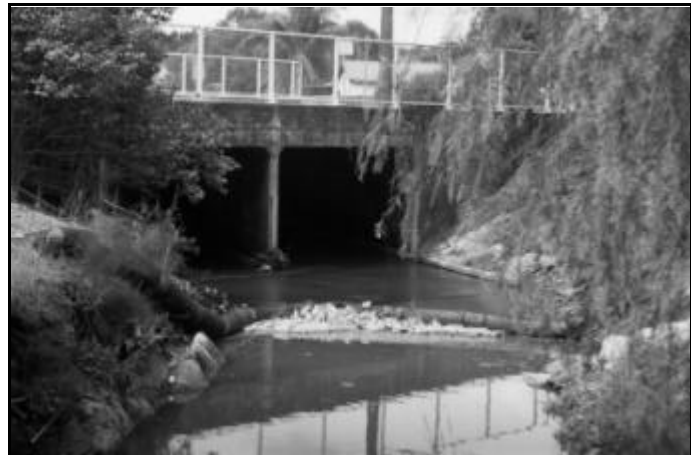
*Litter boom in Greystanes Creek (above)*

1. Begin study at Station Road and walk upstream. Note the constructed banks. Describe the banks and the purpose of the construction.
2. Note the litter boom. Describe any matter caught behind the boom. How could this matter have ended up in the creek?
3. Assign a small group of 2 or 3 students to carefully go down to creek to collect water samples. Perform water tests.
4. Compare this section of creek with the creek downstream from Station Road. What is the difference?  
Why have creeks in UPRC been channellised? Which do you prefer? Why?
